GUTTER @ LOWER EAVE

PANEL SYSTEM: NS-10	
ISSUE / REVISION DATE: 1/11/2013	DETAIL NO. NS10-GTR1
NOT TO SCALE

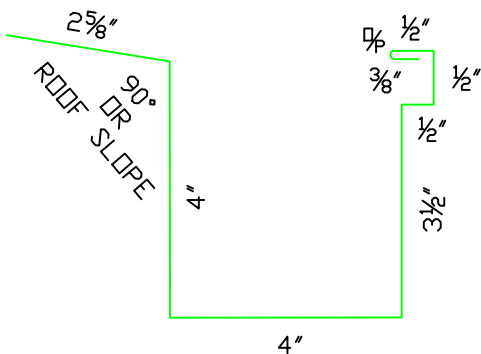
OFFSET CLEAT (OFFC1)

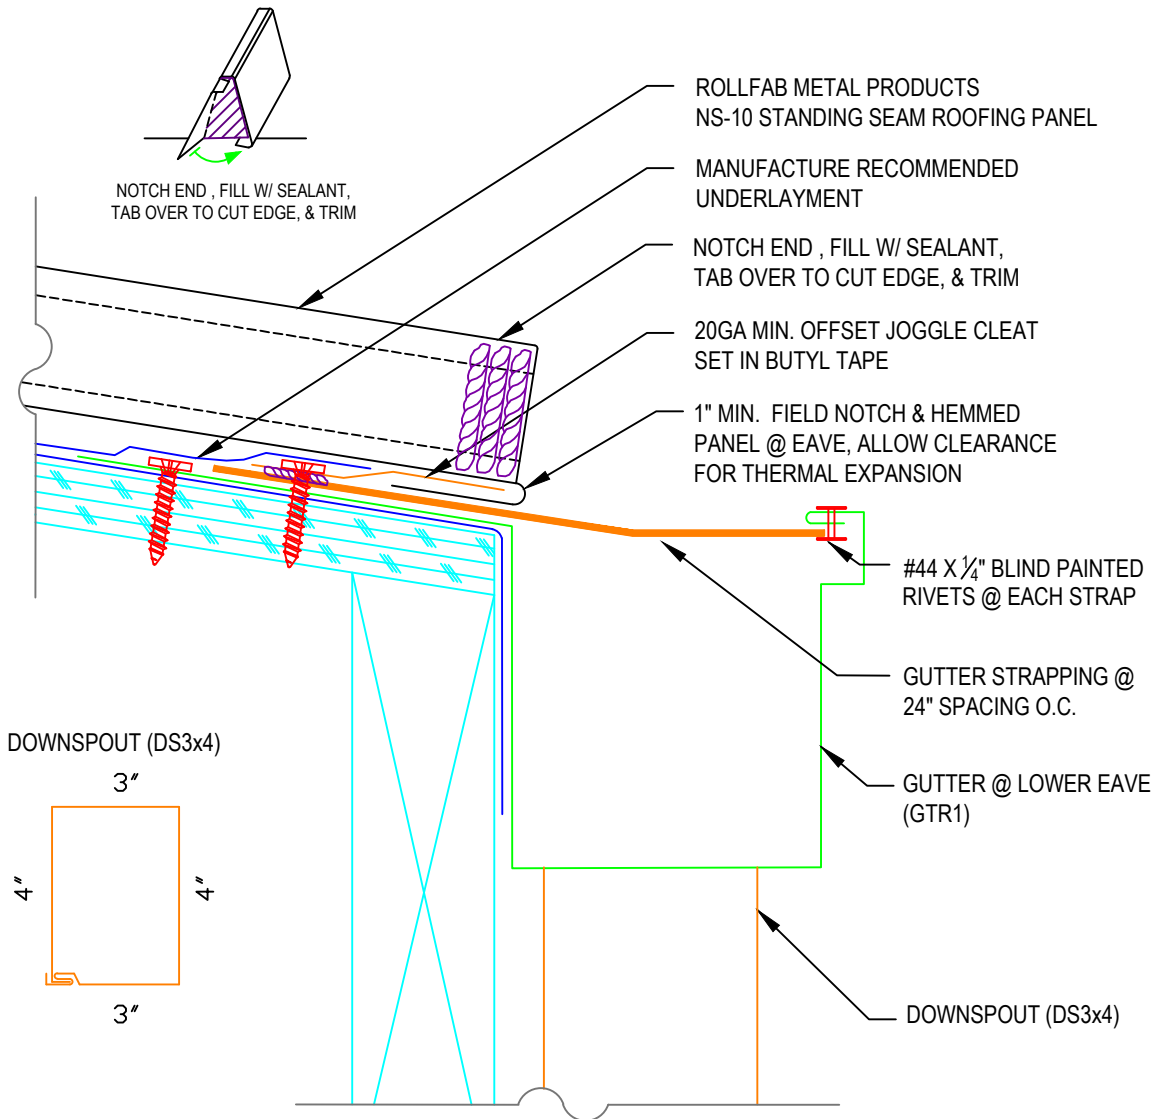
GUTTER @ LOWER EAVE (GTR1)

GUTTER STRAPS (GTR1/ST)

***NOTE: SLIDING SNOW AND ICE COULD CAUSE DAMAGE TO GUTTER SYSTEM.**
